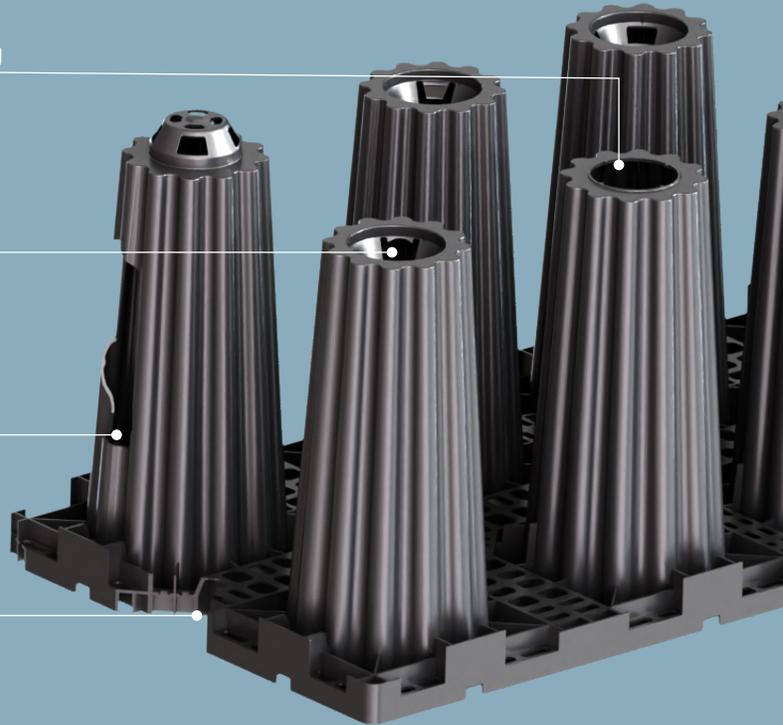
Broken/collapsed seating
UNACCEPTABLE

Broken clip(s)
ACCEPTABLE

Cracks along column(s)
UNACCEPTABLE

Damaged base plate
UNACCEPTABLE

ACO recommends that half-modules be inspected upon delivery to the site and immediately prior to installation to reduce the risk of damaged half-modules being installed. Half-modules damaged during or after the installation process should be removed and replaced with intact half-modules.
